**MALINE CREEK ASBESTOS
SITE CLOSURE AND
STREAMBANK STABILIZATION
STUDY**

ST. LOUIS, MISSOURI

July 1993

TapanAm associates, Inc.

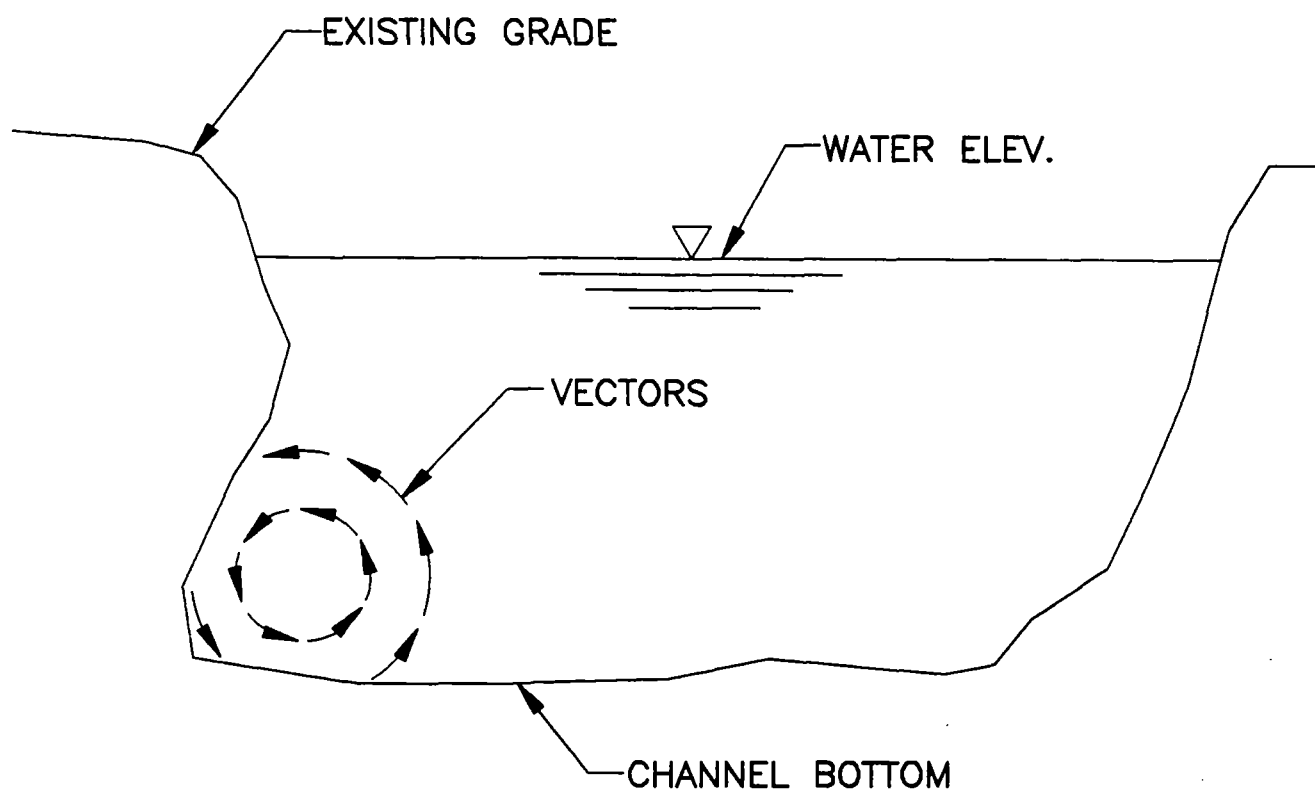
FIGURE II-2
CREEK SECTION SHOWING
SPRIAL FLOW VELOCITY
VECTORS

The spiral currents generated as water moves through bends are of particular concern in the Certainteed-GAF reach. This phenomenon is peculiar to subcritical flow and accounts for much of the embankment scour which can be seen even in some relatively tranquil streams. Such currents describe a helical path in the direction of flow and introduce transverse velocity components to the channel section (Figure II-2). These currents are believed to be caused by filamental velocity differences between the center of the channel and the channel wall induced by friction; centrifugal force which deflects water particles from straight line motion; and a vertical velocity distribution in the approach channel which initiates the spiral motion. Looking downstream, a bend to the right induces counterclockwise motion, while a bend to the left induces clockwise motion. Such currents are probably the primary reason for the severe undermining process seen at and below the Riverview Branch tributary bend. Spiral currents tend to persist for some distance downstream when a curve is followed by a long straight tangent and, therefore, their impact is not merely local. The extensive damage done along the Certainteed-GAF northeast bank well below the bend is a prime example of their effect.

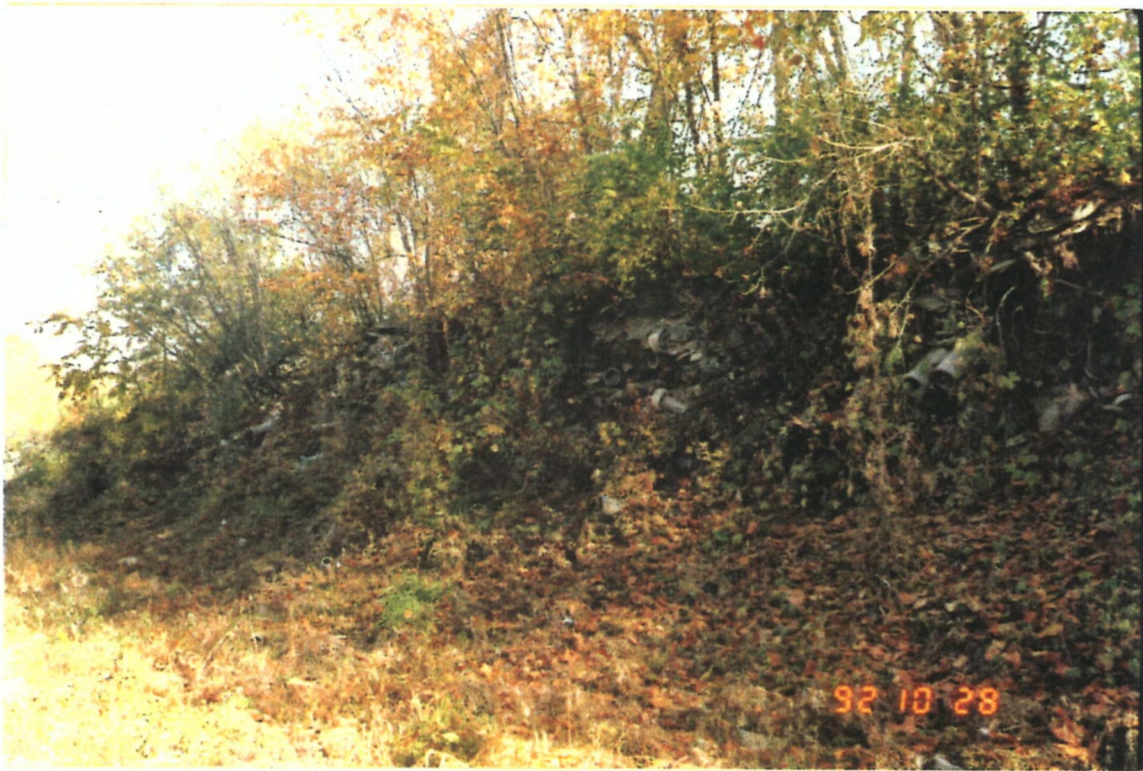
On the surface, in the wooded area along the top of the east bank of the creek, broken pieces of pipe lie scattered amongst the rip-rap and vegetation. More asbestos material is exposed to the surface in the northwestern part of the property where the cap is only

Figure III - 1 Looking North at approximately 1/2 mile
SE of Riverview Branch tributary.

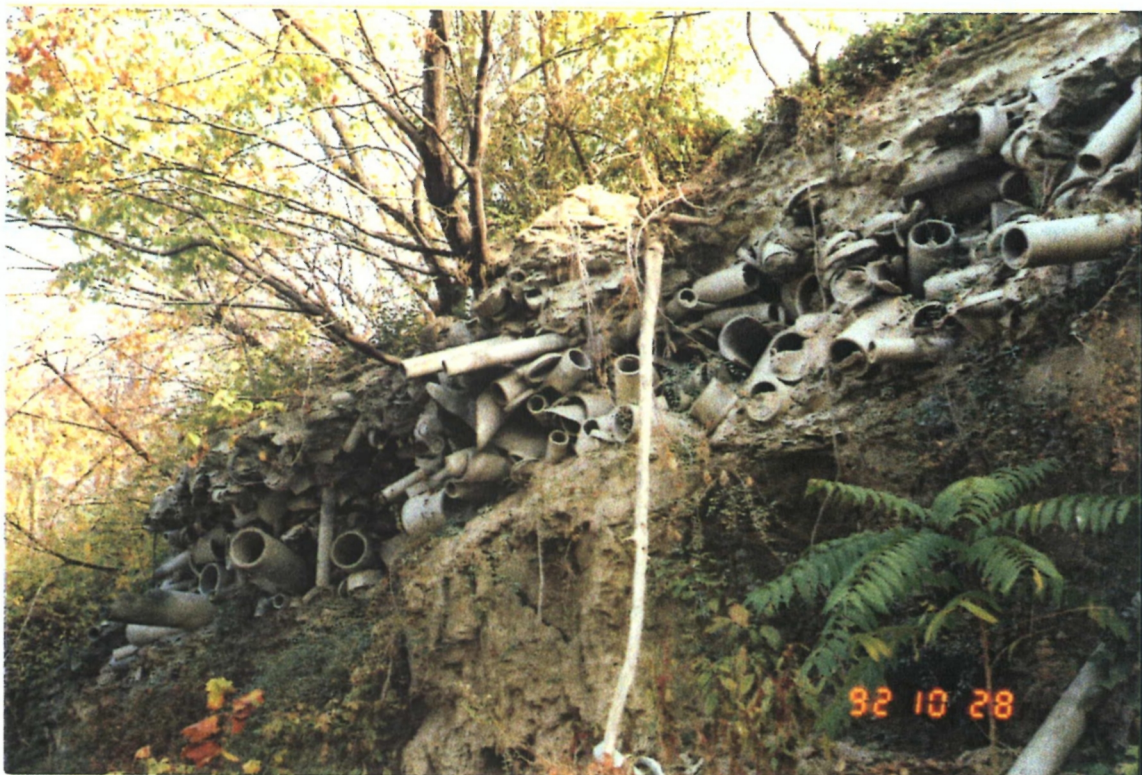
Among the materials found in the collapsing bank underlying the vegetation is the thick layer of asbestos waste products which was used to fill the old creek channel.

Figure III - 2 Close-up of NE bank from Riverview Branch
tributary, approximately 1/2 mile
tributary to show stratum of asbestos
materials

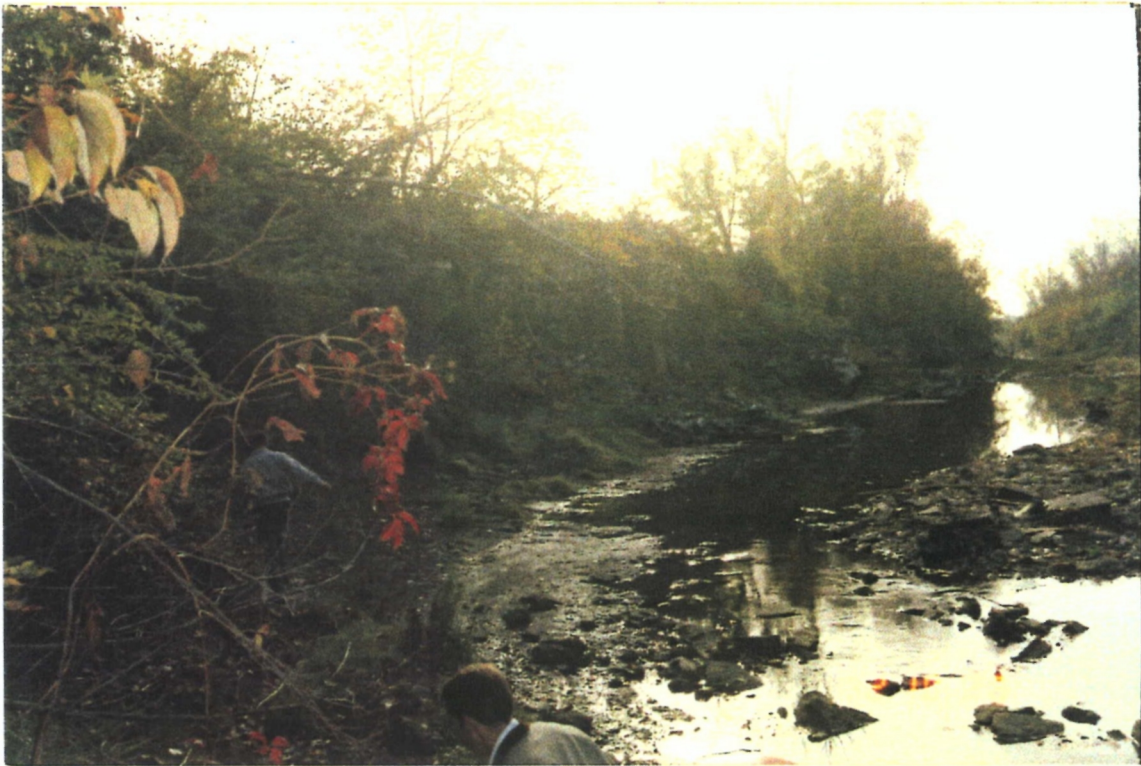
The majority of the asbestos pile in the creek bed is caused by collapse of asbestos material from the bank into the creek bed where water has undermined the soil beneath the stratum (Figure III-3 and III-4). Water has subsequently carried some of this debris downstream, scattering pieces of cement asbestos pipes along the entire length of the creek.

Figure III - 3 Looking SE from Riverview Branch tributary to show asbestos material on creek bed.

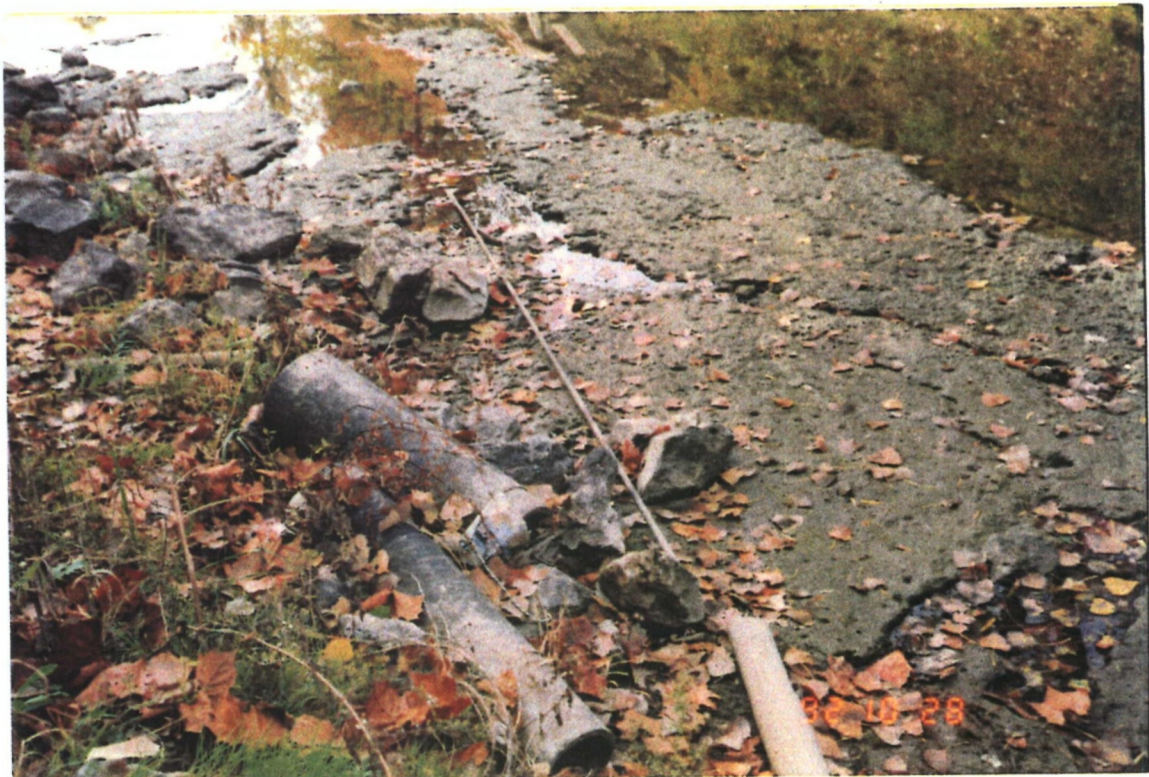
Figure III - 4 Close-up to show asbestos material scattered on creek bed, looking south at Maline Creek from Riverview Branch tributary.

The materials in the creek bed showed signs of advanced deterioration probably due to water erosion and freeze thaw actions. Other factors noted as contributing to the breakdown of the non friable materials include stress induced by plant roots and vehicles running over the materials scattered in the parking area.

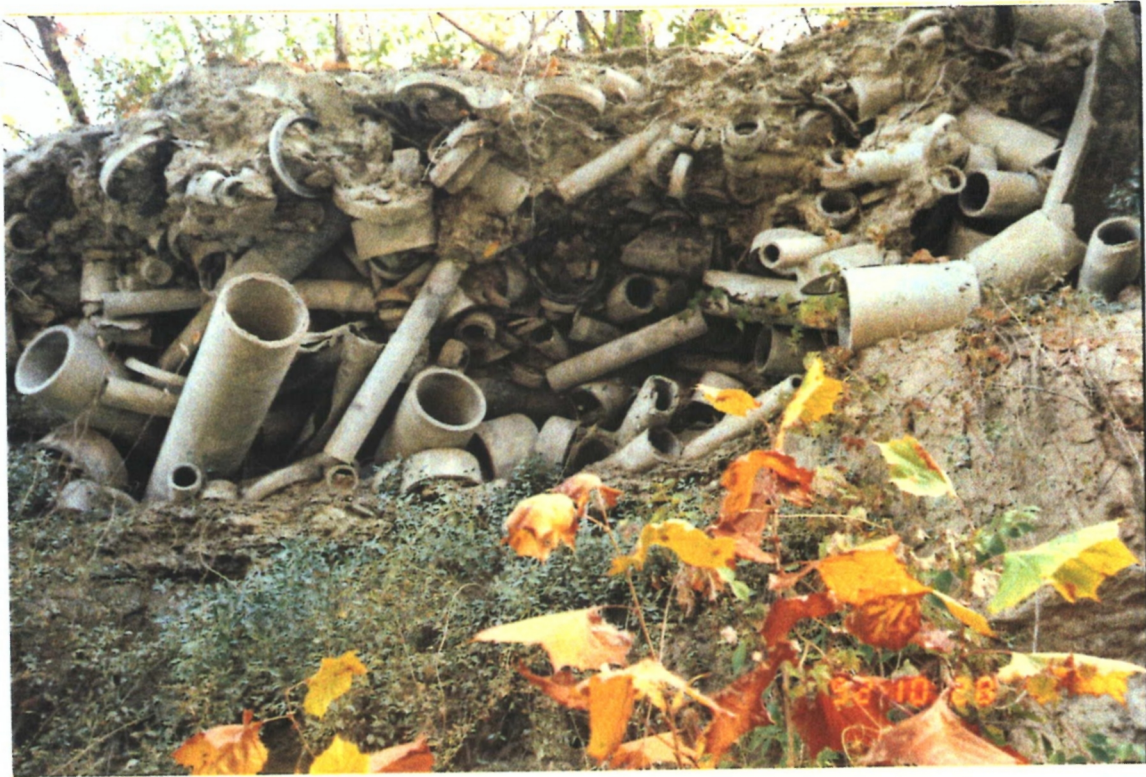
Figure III - 6 Transite pipe, connectors and pipe collars along NE bank from Riverview Branch tributary.

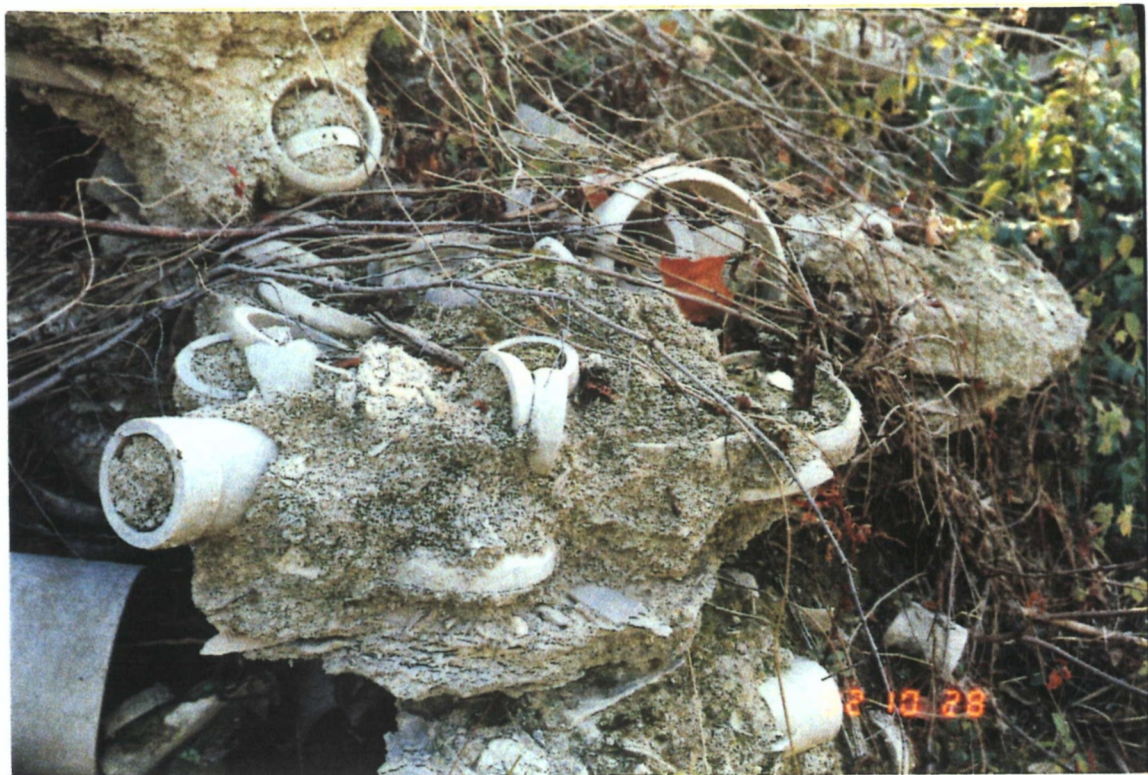
Friable materials identified at the site include pipe insulation, impregnated cloth and solidified cement slurry. Weathering and deterioration of non friable materials may lead to delamination, where the material begins to split and pull apart thus releasing fibers.

Figure III - 7 Close-up of asbestos pipe in solidified slurry.
